DOT/FAA/AR-99/11

Large Engine Uncontained Debris Analysis

May 1999

Final Report

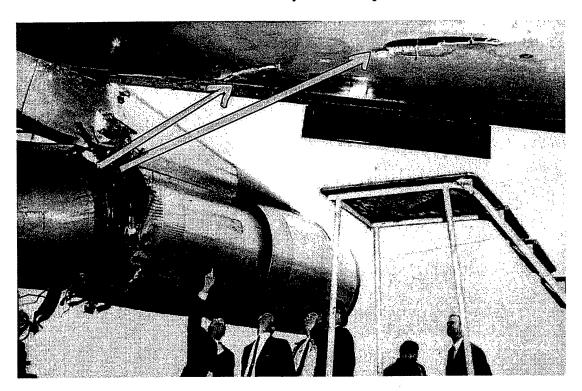
FIGURE 1-1. UNCONTAINED TURBINE DISK EVENT

Uncontained gas turbine engine events, figure 1-1, are a basic threat to aircraft safety. To better defend against this threat, debris characteristics must be accurately defined. Debris characterization includes defining debris size, mass, velocity, trajectory angles, and number of fragments per event type. This report defines these characteristics for different engine types and failure modes. Recommendations for future analysis are also provided.

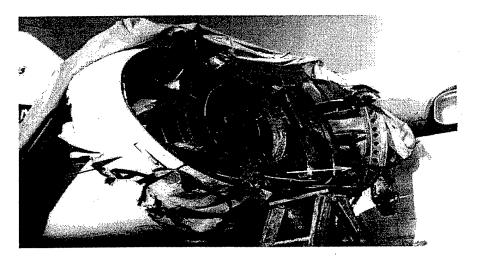
FIGURE 4-12. FAN DISK DAMAGE

For fan disk damage from a disk failure (shown in figure 4-12), figure 4-13 shows the basic trajectory angles to range from +5 and -5 degrees. A 100% normalized disk fragment is used to model fan disk debris. Initial energy levels are near 100,000 ft lbf.

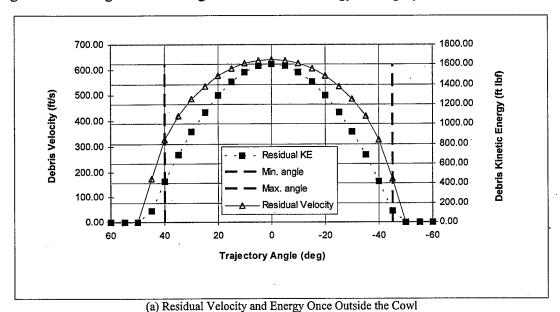
Figure 4-24 a plots debris residual velocity and residual energy upon exiting the cowl. For a fuselage-mounted engine during takeoff, the plot shown in figure 4-24(a) would be virtually unchanged. As previously discussed, figure 4-23 shows a penetration point at 40 degrees from a fuselage-mounted engine. At 40 degrees the residual energy is roughly 400 ft-lbf.

FIGURE 4-24. DEBRIS ENERGY ESTIMATION FOR A 100% COMPRESSOR BLADE

The other extreme from figure 4-23 includes penetrations at -45 degrees from a wing-mounted engine. Figure 4-24(b) plots the debris impact energy after including the aerodynamic forces, resulting in an aft shift of the energy plot. At -45 degrees the debris energy is also near 400 ft-lbf, thus indicating how compressor blade damage can have a wide trajectory angle. Figure 4-25 shows the disk and blade damage from a compressor disk event.

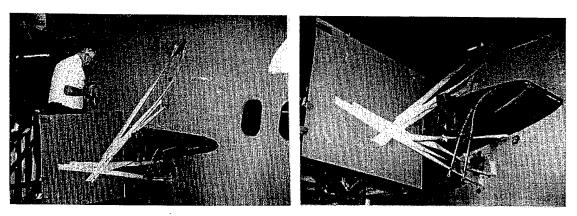
FIGURE 4-25. DISK AND BLADE DAMAGE FROM COMPRESSOR DISK EVENT

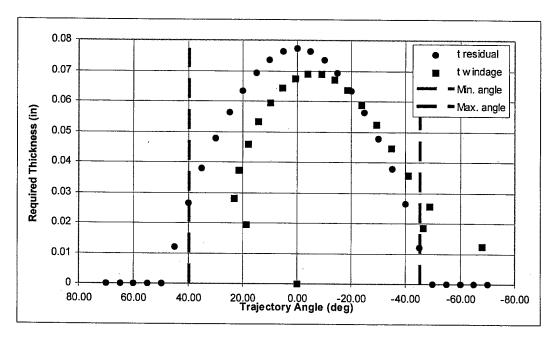
Figure 4-26 plots required skin thickness to defeat the debris versus trajectory angle. While there is compressor damage from 40 to -45 degrees, most of the data is between 15 and -30 degrees. This agrees very well when a typical fuselage thickness of 0.04 to 0.08 inch is considered.

FIGURE 4-26. PREDICTED SKIN THICKNESS TO DEFEAT A 100% COMPRESSOR BLADE

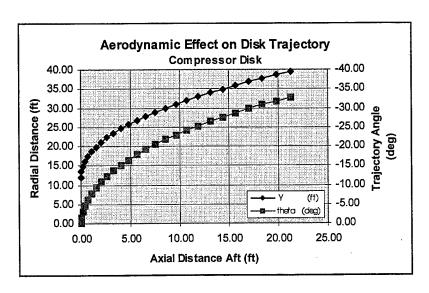
The effect of windage on a disk fragment trajectory was estimated. The sensitivity calculations were conducted at 35,000 ft, Mach 0.85 flight conditions. The disk characteristics used were based on the 50% disk fragment, specifics can be found in table 3-5. The analysis was conducted for a debris fragment traveling 30 feet radially from the engine centerline. At this point, the disk has traveled 8.5 ft aft resulting in a change in trajectory angle of about-22 degrees (figure 4-27).

FIGURE 4-27. COMPRESSOR DISK WINDAGE EFFECTS

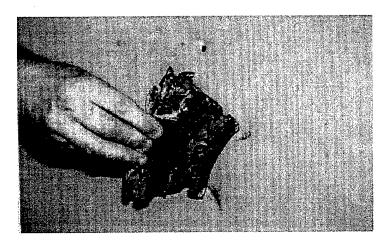
FIGURE 4-28. COMPRESSOR DISK FRAGMENT AFTER PASSING THROUGH THE FUSELAGE

Figure 4-28 shows a compressor disk fragment after passing through the fuselage. Figure 4-29 shows a very tight trajectory band of 5 to -5 degrees for disk debris. Initial energy levels are near 25,000 ft-lbf. These levels are similar to the fan blade energy levels presented earlier (figure 4-6). Disk pieces, however, often enter the fuselage edgewise making them far more likely to penetrate aircraft structure.

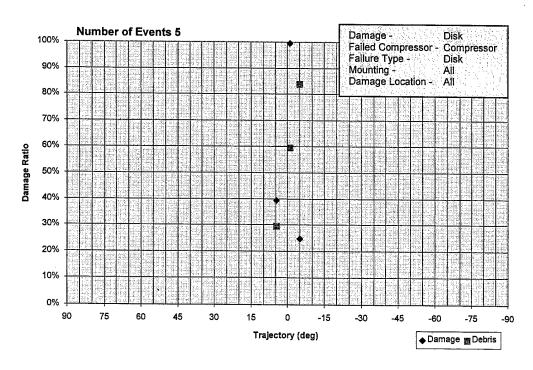
FIGURE 4-29. COMPRESSOR DISK DAMAGE FROM A DISK EVENT

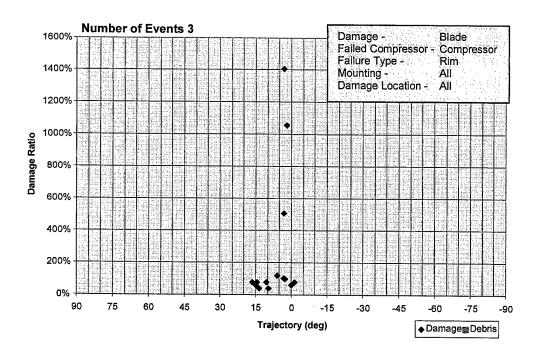
Figure 4-30 shows blade damage from a rim event. Notice most of the damage clusters near the 100% damage ratio. Hence, the debris energy estimates from figure 4-24 still apply. For the rim

FIGURE 4-30. COMPRESSOR BLADE DAMAGE FROM A RIM EVENT

events, the trajectory angles are from 0 to 15 degrees, but only three events are cataloged. Additional events may expand the trajectory angles to the limits shown in figure 4-23.

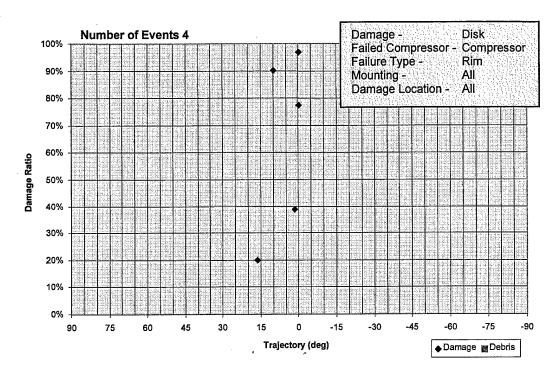
Figure 4-31 shows the trajectory range for compressor rim events. Estimated initial energy levels approach 30,000 ft-lbf, but these components also enter edgewise making them difficult to defeat. Component size of a 100% rim piece should be used.

FIGURE 4-31. COMPRESSOR DISK DAMAGE FROM A RIM EVENT

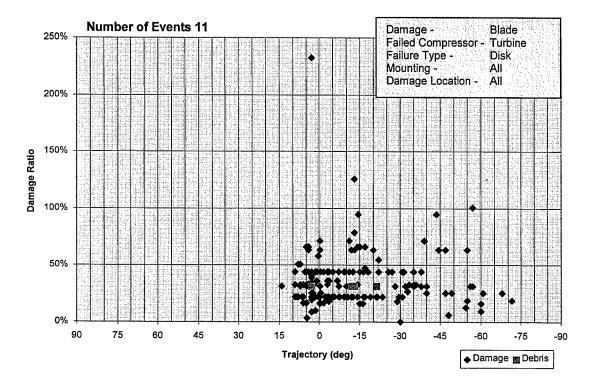
Figure 4-32 shows a representative turbine blade debris size to be 50% or less. The trajectory angles are between 15 and -75 degrees, which are quite extreme. Every event shown in figure 4-32 was a wing-mounted engine; no fuselage-mounted turbine disk events are in the debris database. Figure 4-33 shows fuselage damage from a wing-mounted engine from 15 degrees to -45 degrees. Figure 4-34 shows the near-field wing damage from a wing-mounted engine to vary from 10 to -75 degrees. These two charts indicate that there is a significant difference in trajectories from near field to far field. A possible explanation, as has been seen in the residual velocity and kinetic energy plots, is that the debris traveling to the fuselage at smaller angles has higher energy than the debris traveling at the large aft trajectories. For the purpose of the turbine blade damage from disk failure the trajectories of interest will be 15 to -45 degrees.

FIGURE 4-32. TURBINE BLADE DAMAGE FROM A DISK EVENT

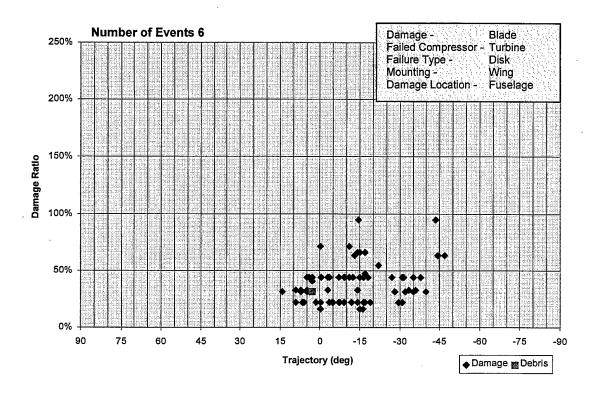
FIGURE 4-33. TURBINE BLADE FUSELAGE DAMAGE FROM A DISK EVENT

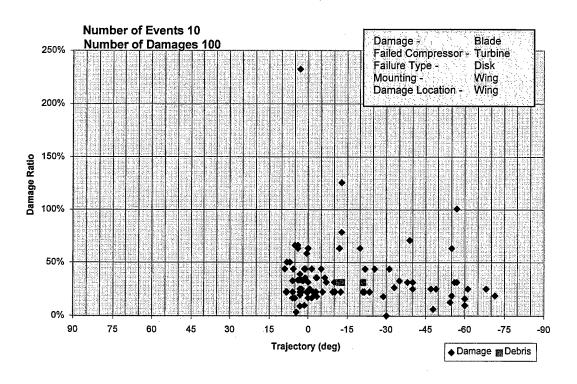
FIGURE 4-34. TURBINE BLADE WING DAMAGE FROM A DISK EVENT

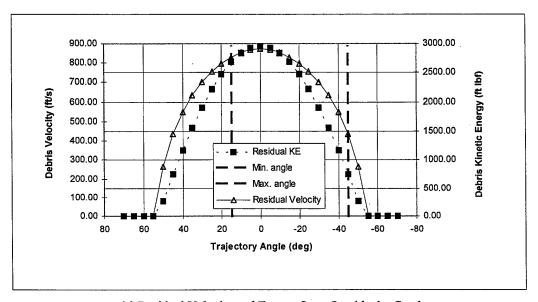
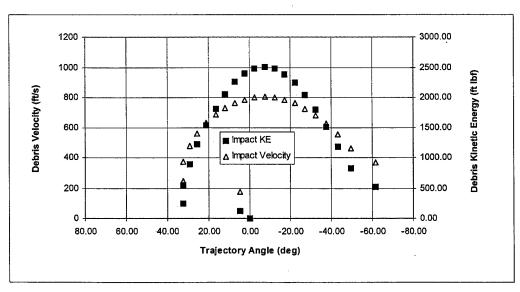
In keeping with the debris energy model presented in figure 2-1, a debris energy analysis was performed using a 0.04 inch cowl over the turbine. Debris characteristics are provided in table 3-5. Seventy-five percent of the debris initial velocity was used in this analysis. The results for the 100% HPT blade are shown in figure 4-35. Figure 4-36 shows the required skin thickness to defeat the associated energy levels (figure 4-35). The analysis indicates that there is sufficient energy for a fragment to penetrate a 0.040-inch aluminum skin from approximately 30 degrees forward to -40 degrees aft.

FIGURE 4-35. DEBRIS ENERGY ESTIMATION FOR A 100% HP TURBINE BLADE

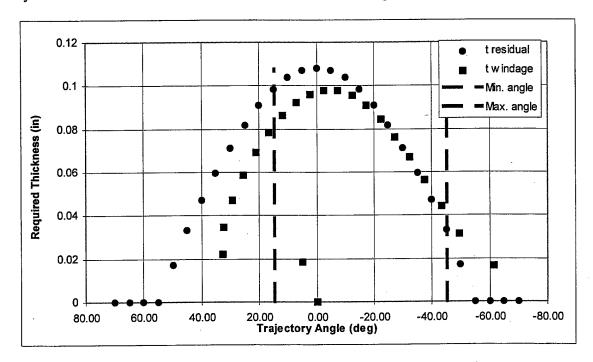
FIGURE 4-36. PREDICTED SKIN THICKNESS TO DEFEAT A 100% HP TURBINE BLADE

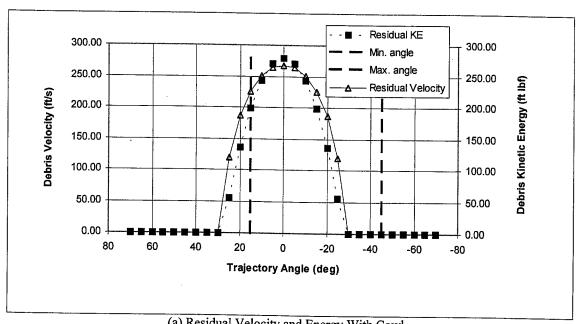
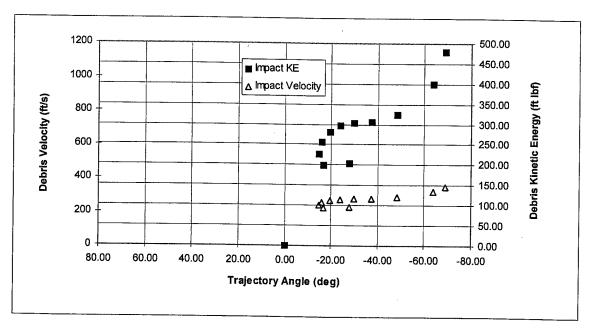
A similar analysis was conducted on high bypass ratio LPT blade debris. Figures 4-37 and 4-38 define the debris residual energy levels and plate thickness required to stop the fragment. This analysis shows that there is very low debris residual energy if the debris is to pass through the cowl. An additional analysis was conducted to define the highest debris energy level. This analysis was conducted such that there was no energy loss from the debris passing through the cowling (i.e., the cowl had a pre-existing hole). The initial velocity used is 75% of that shown in table 3-5. Results of this analysis (figures 4-39 and 4-40) show that although the energy levels are higher than the case with the cowl, the residual energies are still low and likely would not be a significant hazard to the aircraft.

FIGURE 4-37. DEBRIS ENERGY ESTIMATION FOR HBR 50% LP TURBINE BLADE WITH THE COWL

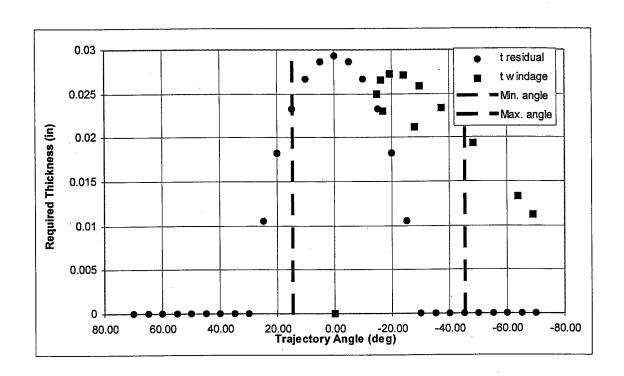
FIGURE 4-38. PREDICTED SKIN THICKNESS TO DEFEAT A HBR 50% LP TURBINE BLADE WITH THE COWL

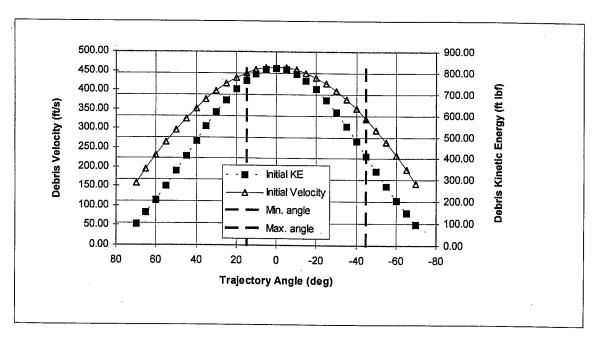
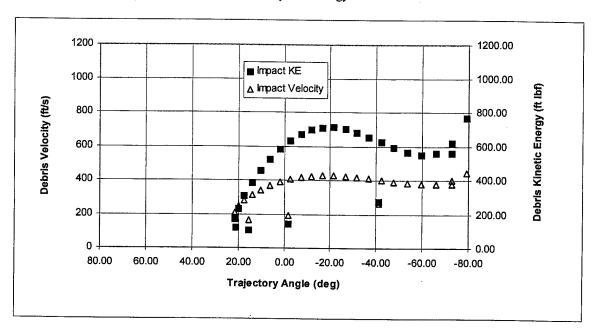
FIGURE 4-39. DEBRIS ENERGY ESTIMATION FOR HBR 50% LP TURBINE BLADE WITHOUT THE COWL

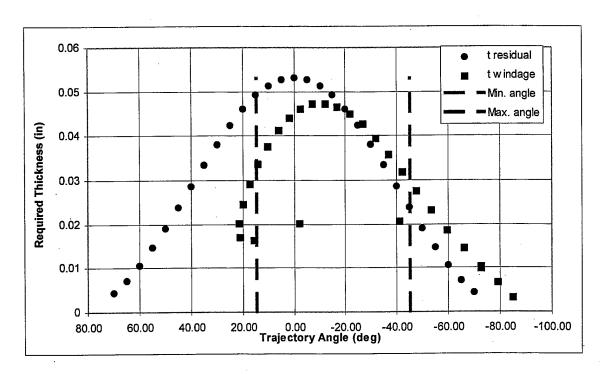
FIGURE 4-40. PREDICTED SKIN THICKNESS TO DEFEAT A HBR 50% LP TURBINE BLADE WITHOUT THE COWL

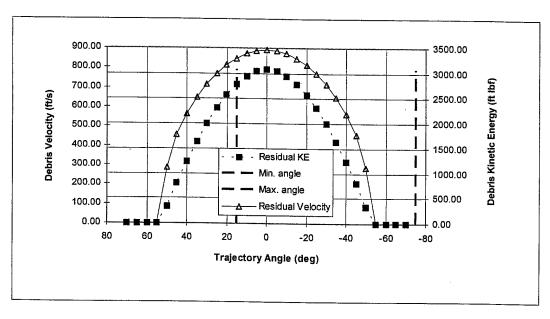
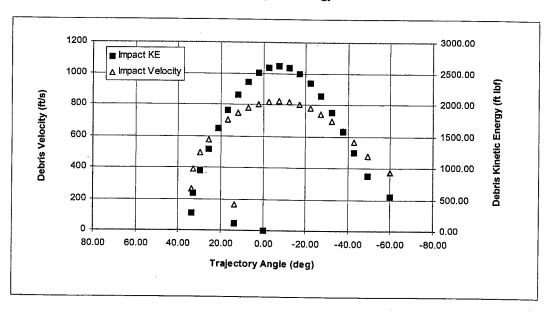
This analysis was conduct in the same fashion as the HBR LPT analysis. Due to the significant increase in rotor speed and thus initial velocity (table 3-5), debris energy levels are considerably higher (figures 4-41 and 4-42). Peak kinetic energy (KE) values of over 3000 ft-lbf could pose a threat to the aircraft if the impact occurred at a high impact orientation (edge on). Penetration of a 0.040-inch skin would occur between 35 and -45 degrees. An additional analysis was conducted without the cowl and peak energies of over 4000 ft-lbf (figures 4-43 and 4-44).

FIGURE 4-41. DEBRIS ENERGY ESTIMATION FOR LBR 50% LP TURBINE BLADE WITH THE COWL

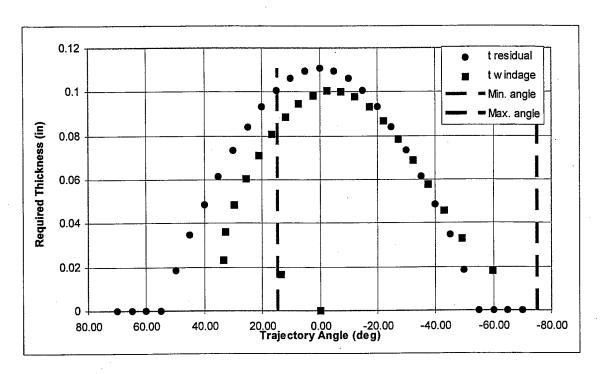
FIGURE 4-42. PREDICTED SKIN THICKNESS TO DEFEAT A LBR 50% LP TURBINE BLADE WITH THE COWL

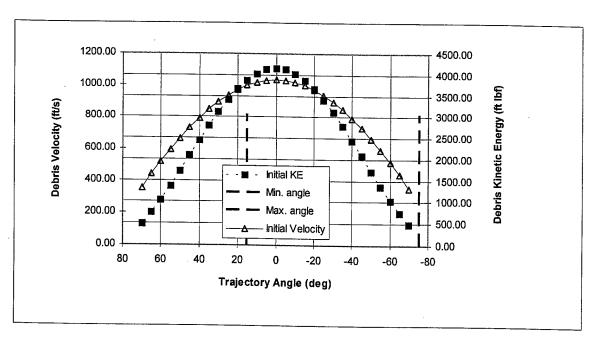
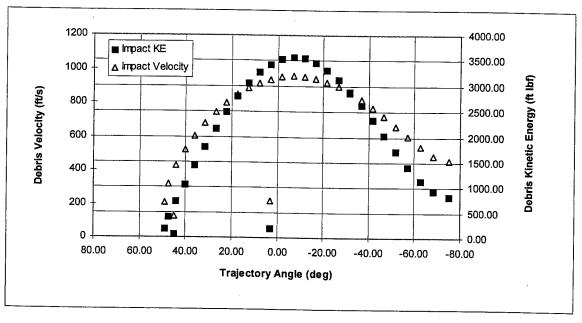
FIGURE 4-43. DEBRIS ENERGY ESTIMATION FOR LBR 50% LP TURBINE BLADE WITHOUT THE COWL

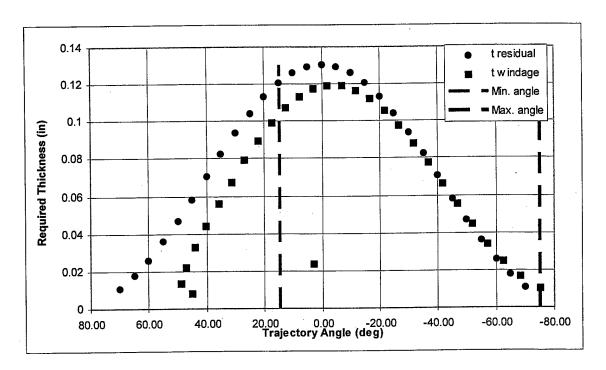
FIGURE 4-44. PREDICTED SKIN THICKNESS TO DEFEAT A LBR 50% LP TURBINE BLADE WITHOUT THE COWL

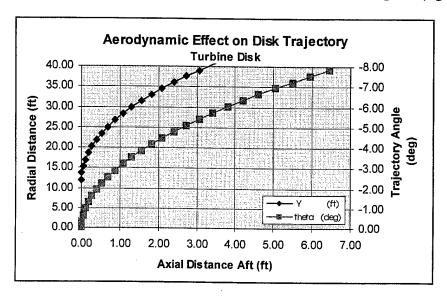
The effect of windage on a disk fragment trajectory was estimated. The calculations were conducted at 35,000 ft, Mach 0.85 flight conditions. The disk characteristics used were based on the 100% disk fragment, specifics can be found in table 3-5. The analysis was conducted for a debris fragment traveling 30 feet radially from the engine centerline. At this point, the disk has traveled 1.3 ft aft resulting in a change in trajectory angle of about -3.5 degrees (figure 4-36).

FIGURE 4-45. TURBINE DISK AERODYNAMIC EFFECTS

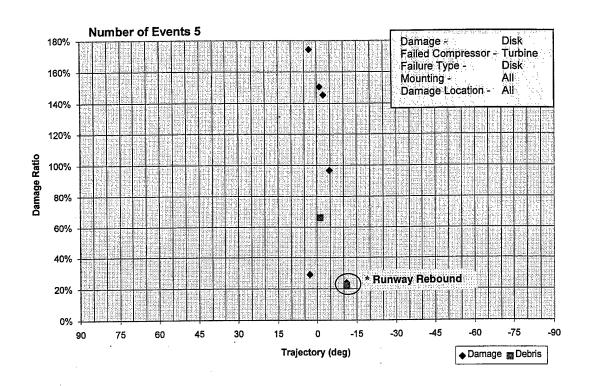
Figure 4-46 shows tight trajectory angles from 5 to -5 degrees for turbine disk damage. The aft trajectory angle extends to -13 degrees when runway rebound is included. Initial kinetic energy is near 340,000 ft-lbf for half a disk. Debris residual energy estimates after penetrating the engine casing are not presented.

FIGURE 4-46. TURBINE DISK DAMAGE FROM A DISK EVENT

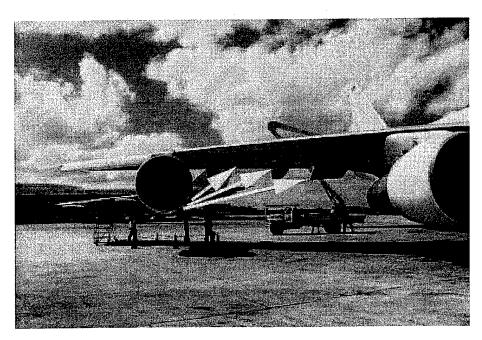
Figure 4-47 shows the trajectory of a rim failure event. Figure 4-48 shows the turbine rim fragments. Figure 4-49 plots turbine blade damage from a rim failure event. This figure shows trajectory angles skewed to the aft direction for a disk failure mode commonly referred to as a "rim-peal." This failure mode occurs for at least two reasons: (1) a spacer or thin-wall sealing ring attached to the disk may fracture in such a way that it "unpeals" from the rotor, and (2) a circumferential fracture under the rim of some disk designs which progress circumfrentially up to 180 degrees before terminating in a radial fracture that releases a portion of the rim. This particle presents itself as a edge-on threat as it passes through the engine cowling. This type of debris has a long length, equivalent to the diameter of the rotor disk and a tumbling action which permits it to be significantly affected by windage effects.

FIGURE 4-47. TRAJECTORY OF RIM FAILURE EVENT

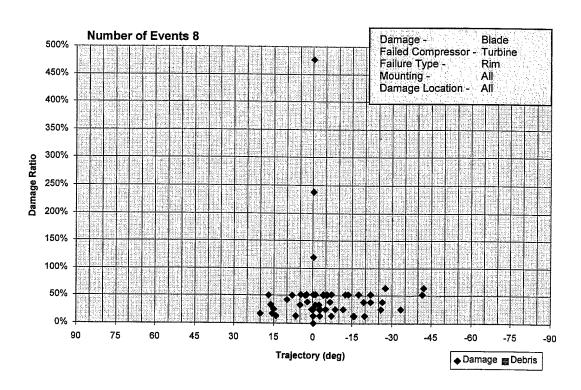
Most of the damage is below the 100% damage ratio allowing figures 4-35, 4-37, and 4-41 to be used for debris energy estimation of HPT and LPT blades respectively. Trajectory angles are from 20 to -45 degrees. Noticeably absent are the large aft trajectory angles. All of this data was also from wing-mounted engines.

FIGURE 4-49. TURBINE BLADE DAMAGE FROM A RIM EVENT

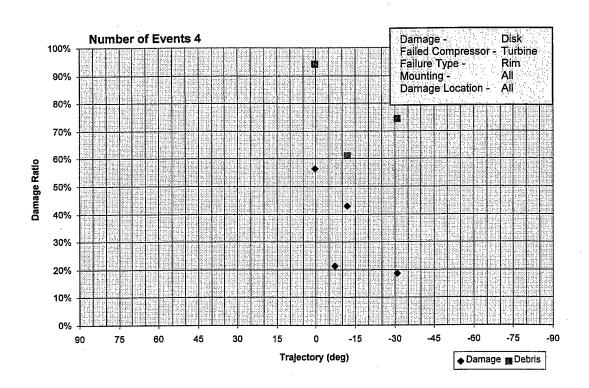
Figure 4-50 shows the fuselage damage from turbine rim debris. Figure 4-51 shows the trajectory angles to range from 0 to -30 degrees. A 50% damage ratio should be used to characterize the piece. Initial energy approaches 160,000 ft-lbf.

FIGURE 4-51. TURBINE DISK DAMAGE FROM A RIM EVENT

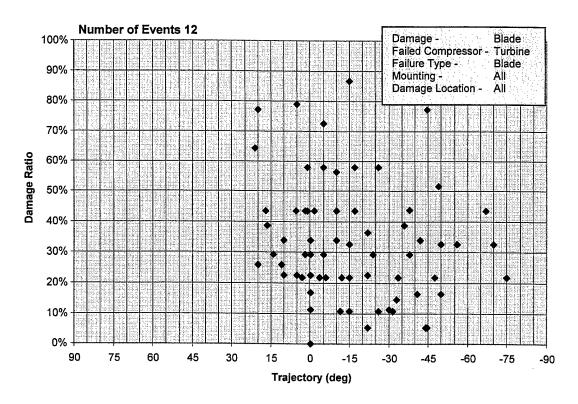
Figure 4-52 plots data for all blade failure events. A majority of the data are below the 50% damage ratio level with trajectory angles between 20 and -75 degrees. These trends are remarkably similar to the blade damage trends from the disk failure events.

FIGURE 4-52. TURBINE BLADE DAMAGE FROM A BLADE EVENT

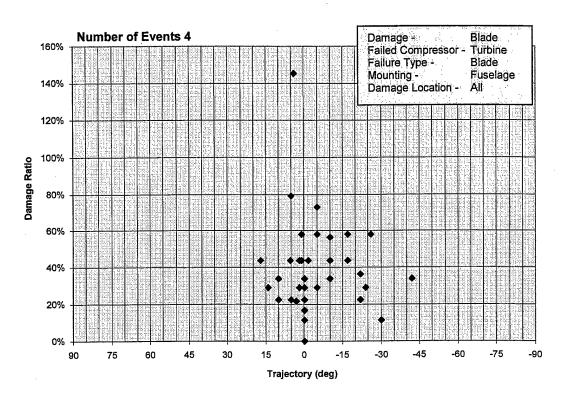
Figure 4-53 only plots fuselage-mounted engine data and shows the trajectory angles to range from 20 to -45 degrees. Figure 4-54 shows wing damage to range from 20 to -75 degrees. These trends are practically identical to the fan blade damage trends from disk events (figures 4-33 and 4-34, respectively). High-pressure turbine blade damage from blade events are plotted in figure 4-55. The data show a trajectory spread of 20 to -50 degrees, with fragment sizes ranging up to 90% of the blade length. Excluding the damages of unknown size at 0%, half of the damages are above 50%. Low-pressure turbine blade damage from blade events are plotted in figure 4-56. The data show trajectory spread angles of 17 to -75 degrees, with fragment sizes falling mostly within the 50% range.

There is an additional factor to address, blade failure from the last turbine stage. Seven of the twelve events shown in figure 4-53 occurred from the final stage. Three were low bypass ratio engines and are shown in figure 4-57. The trajectory angles range from 15 to -45 degrees showing no propensity for producing large aft trajectories. High bypass ratio engines do have this trend as shown in figure 4-58. Whether the large aft angles are due to the final stage failure of a high bypass ratio engine or due to inherent wing location relative to the engine cannot be resolved from the debris database. See discussion in 4.3.3.2.

FIGURE 4-53. TURBINE BLADE DAMAGE FROM A BLADE EVENT FOR FUSELAGE-MOUNTED ENGINES

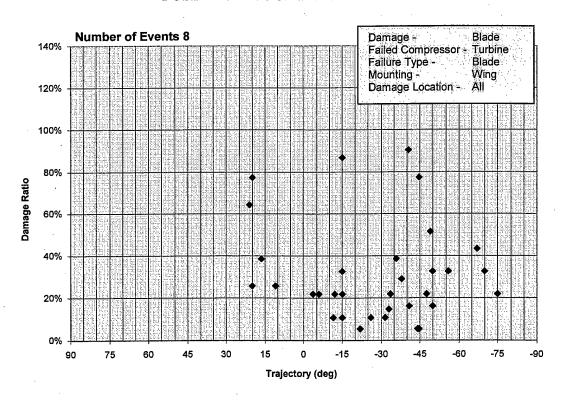
FIGURE 4-54. TURBINE BLADE DAMAGE FROM A BLADE EVENT FOR WING-MOUNTED ENGINES

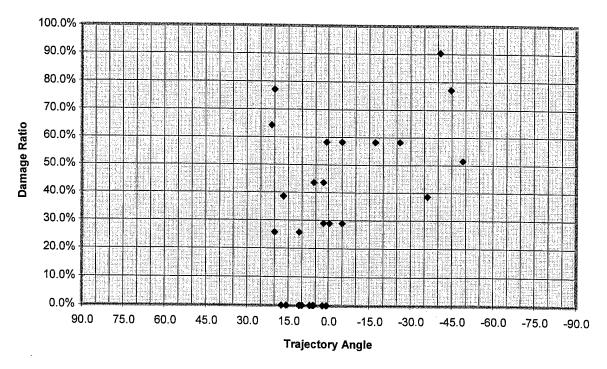
FIGURE 4-55. HP TURBINE BLADE DAMAGE FROM A BLADE EVENT

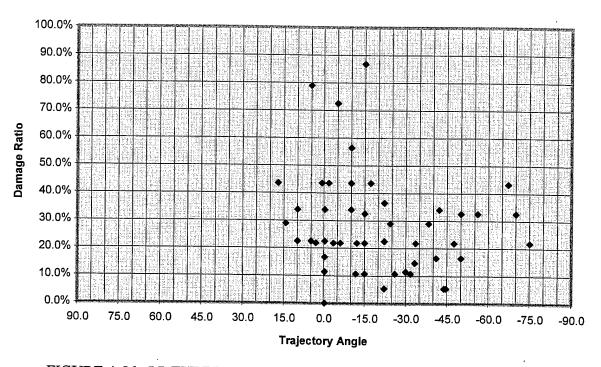
FIGURE 4-56. LP TURBINE BLADE DAMAGE FROM A BLADE EVENT

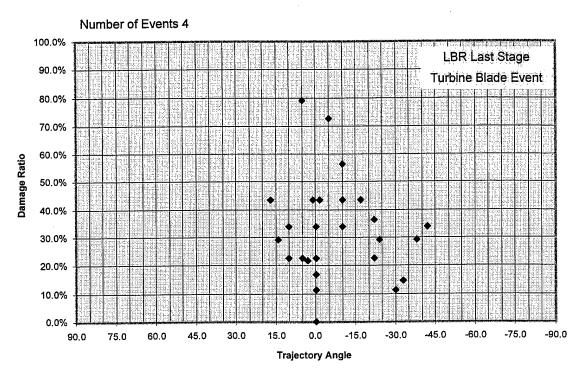
FIGURE 4-57. TURBINE BLADE DAMAGE FROM THE LAST STAGE OF LOW BYPASS RATIO ENGINES

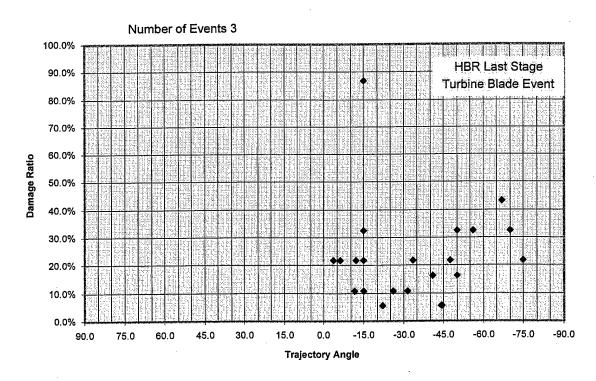
FIGURE 4-58. TURBINE BLADE DAMAGE FROM THE LAST STAGE OF HIGH BYPASS RATIO ENGINES

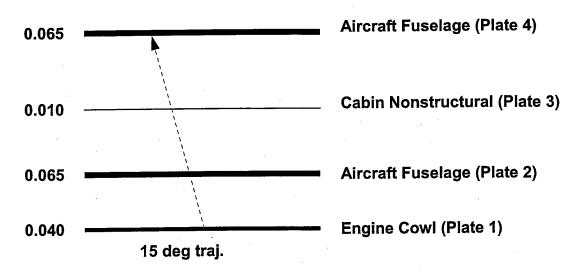
Figure 6-1 shows the model used in the analysis. The actual aircraft skin thickness is 0.04", but to account for frames, the thickness was increased to 0.065". The blade fragment of interest was a blade root section with the dovetail attached. This fragment was found wedged in the fuselage skin. The fragment was approximately 7 inches long and 5.5 inches wide and weighed about 1.5 lb. The initial release velocities for the blade root fragment and tip fragment were 788 and 1382 ft/sec respectively. Table 6-4 shows the analysis conducted for the blade root fragment at its initial velocity. The analysis indicates that the fragment would have penetrated both sides of the aircraft fuselage with a residual velocity of 370 ft/sec. Using 75% of the initial velocity, the fragment was unable to penetrate the far side of the fuselage, as was the case for this event (table 6-4).

For the blade tip fragment, the results are much the same. Using the initial velocity, the fragment penetrates all the way through the aircraft with a residual velocity of 420 ft/sec (table 6-5). Using 75% of the initial debris velocity (table 6-6), the fragment does not penetrate the far side of the fuselage (plate 4), again matching the event data.

FIGURE 6-1. ENGINE COWL AND AIRCRAFT MODEL
